# Chatfield Marina

## Reallocation Impact Assessment Report

### Chatfield State Park - Littleton, CO

February 2011

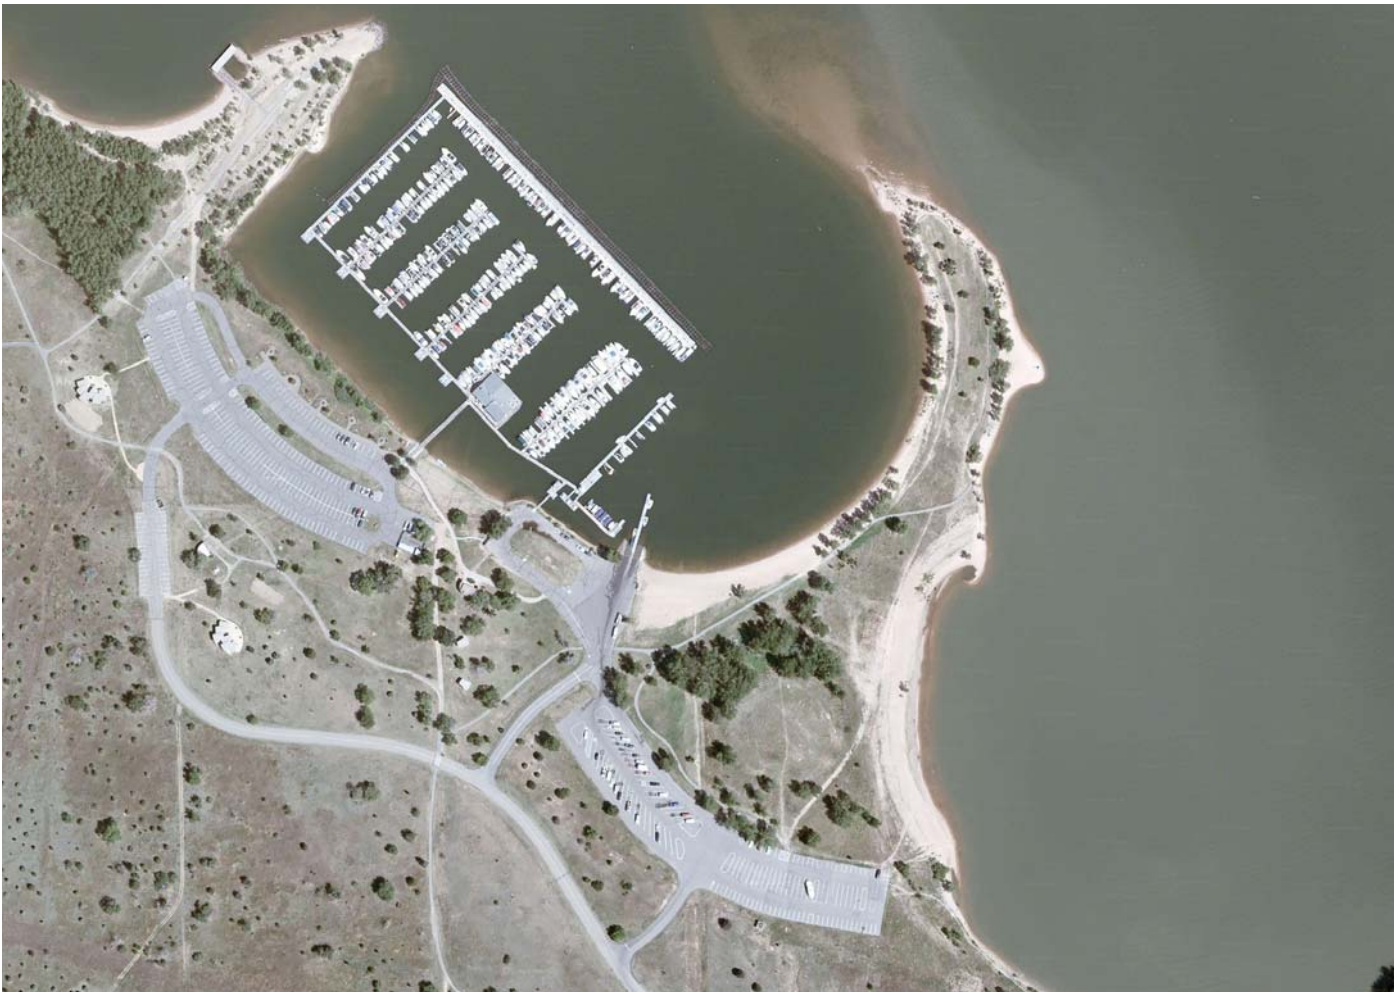
3-1 Existing Marina Layout

The existing floating dock system was built by the operator incrementally over the last 27 years. The dock system consists of welded tube steel frames, polyethylene encased polystyrene floats, and lpe (sustainable Brazilian hardwood) decking. The frames have field welded connections along the mainwalks and hinged connections at finger and secondary platform connections. The shallow nature of the tube frames results in significant flexure (bounce) of the dock system when subject to pedestrian loads. The frames, floats, and decking are all in excellent condition and have been carefully maintained.

The system is more sensitive to wave and wake action than modern factory manufactured systems and requires wave and wake protection along with protection from moving ice.

Replacement of the dock system with a new one will allow for a more robust system that will withstand the more exposed conditions and the increased loadings from wave and ice conditions.

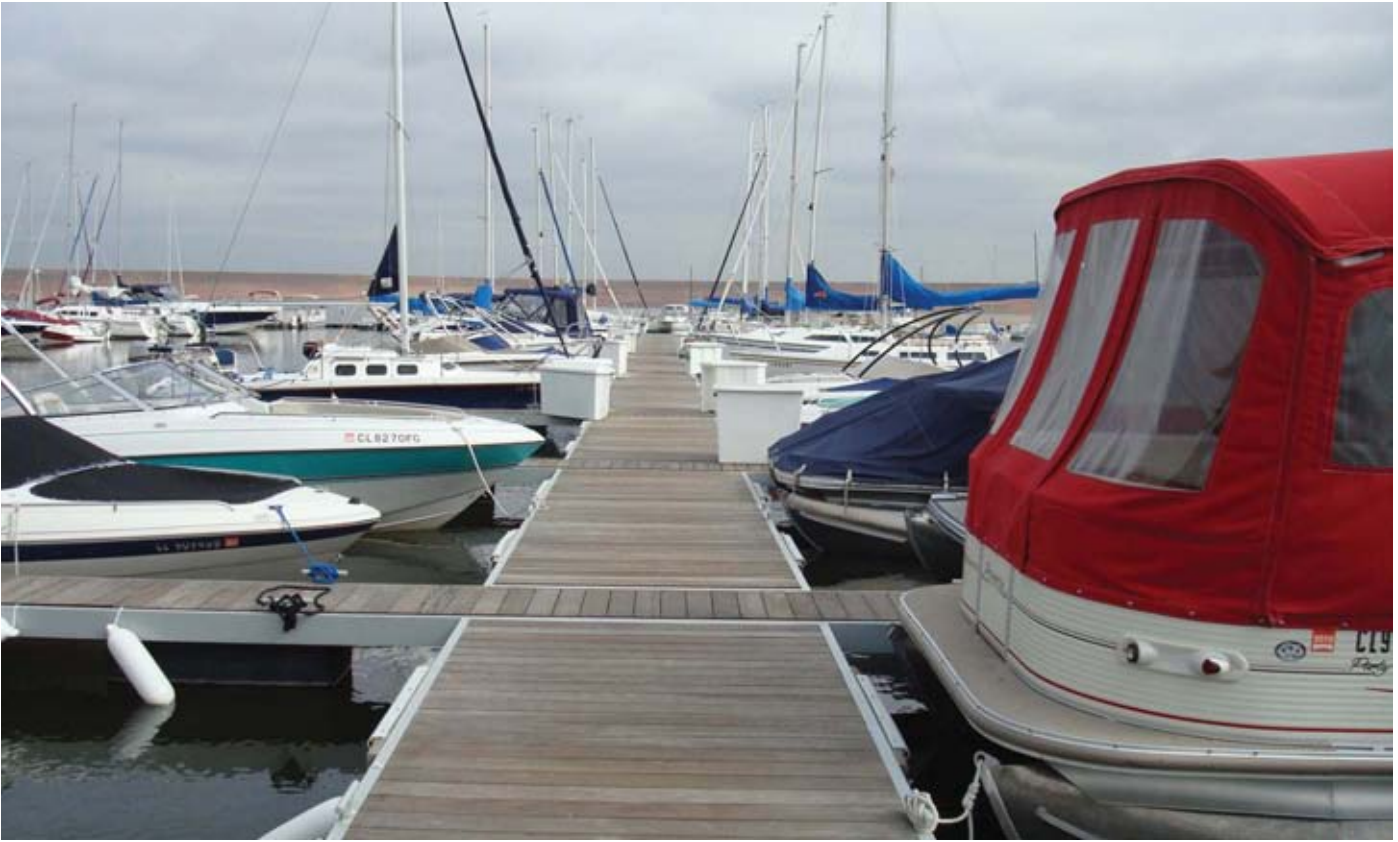
3-3 Floating Docks

Access to the docks is controlled by keypad accessed security gates. One gate is located on the restaurant platform and a second gate controls access from the fuel dock gangway. Currently there are 334 slips ranging from 25 to 40 feet in length.

The floating picnic platforms are hinged to the south end of the floating marina and behave structurally as semi independent rafts. They provide a place for grilling and picnicking within the confines of the floating marina.

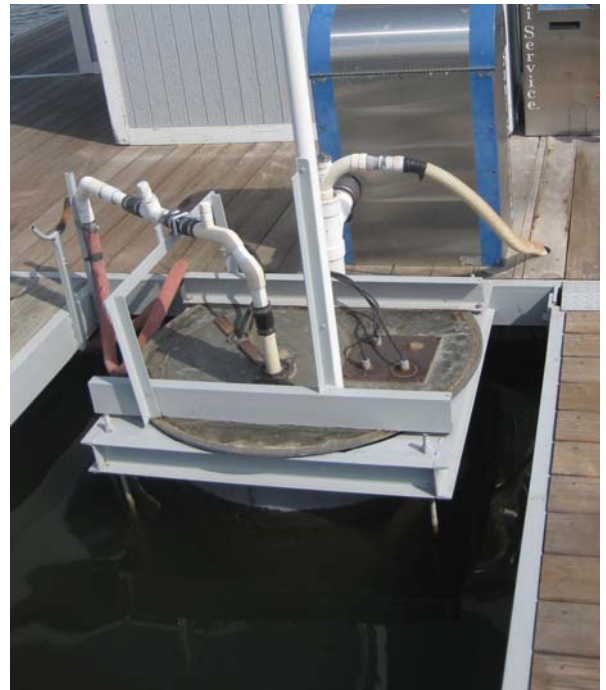
3-11 Pump Out Station

The Pumpout fixture is supplemented by a dock mounted lift station. This boosts the pressure and deposits the waste in a floating platform lift station that discharges the waste to the upland lift station.

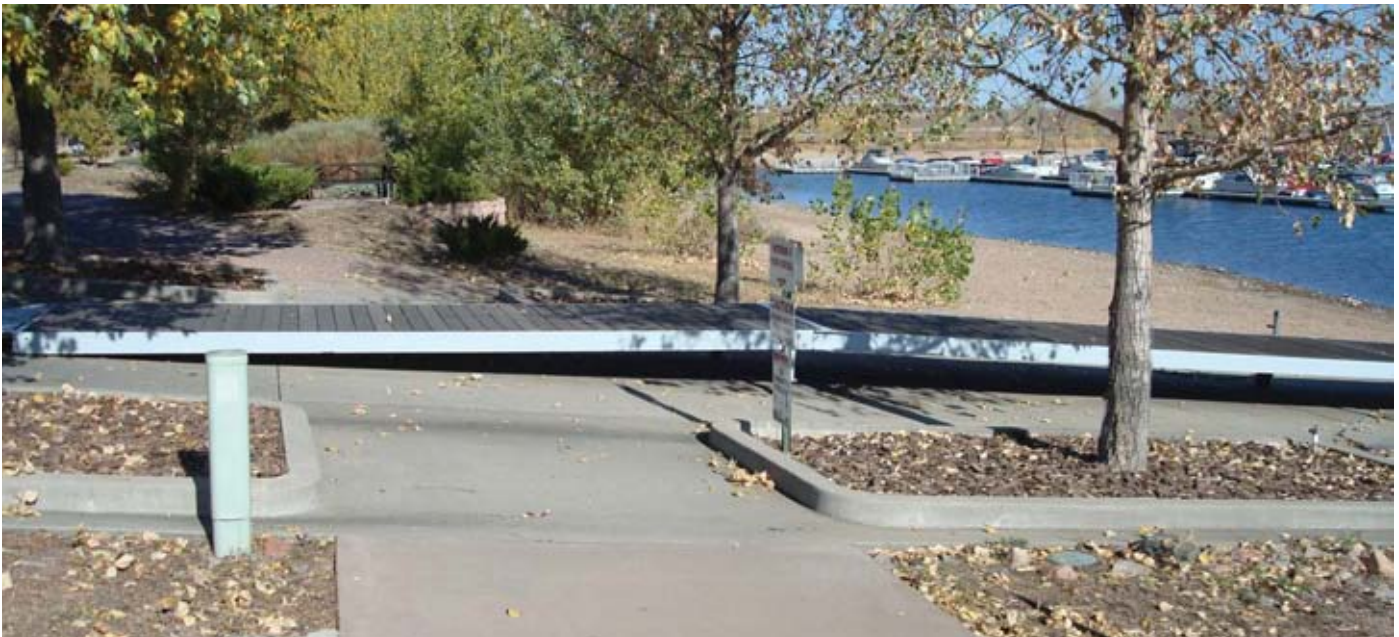
3-14 Gangway Approach

The primary access to the floating marina is by a 150' long articulated floating walkway that rests on a concrete accessway during low water conditions. The gangway functions until the water elevation reaches 5440'. No security gates are provided on the gangway, but access is through a gate located on the floating restaurant platform.

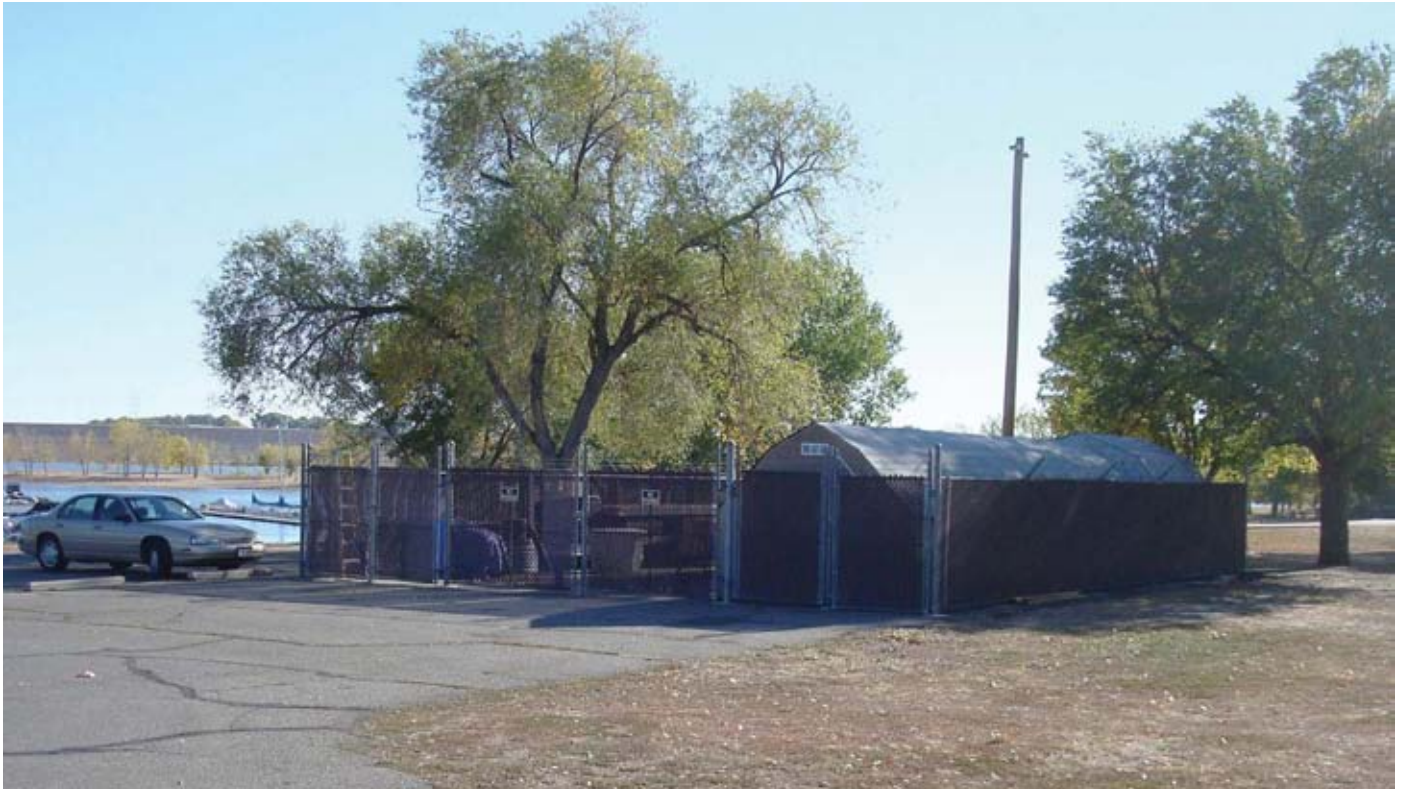
3-18 Marina Storage Yard

The marina has a fenced storage yard at the east end of the parking lot that provides a secured area for maintenance equipment and for paddleboat storage during the off season.

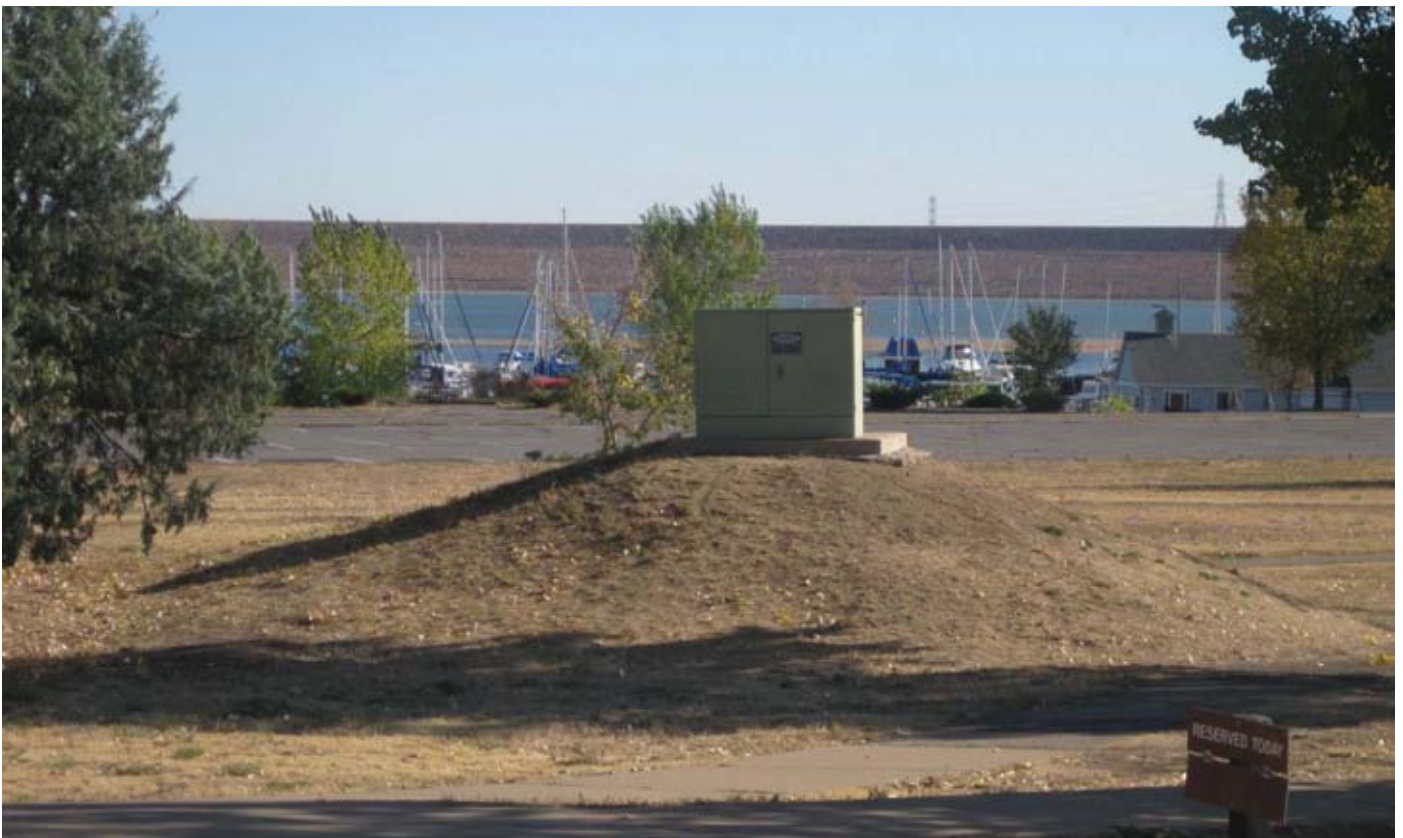
3-19 Primary Transformer

The electrical transmission lines throughout the park are buried. The primary transformer for the marina is located on an elevated mound south of the marina parking lot at approximate elevation 5,447' although the adjacent land is below the 5444' elevation. The electrical feed to the docks is hidden below the floating restaurant.

The power to the marina requires complete reconfiguration. The most efficient alternative would be to provide 480V or 600V power to a dock mounted transformer and distribute power to the restrooms, administration building, fuel dock and marina docks from that location. The upland distribution transformer will need to be located above the 50 year flood elevation.

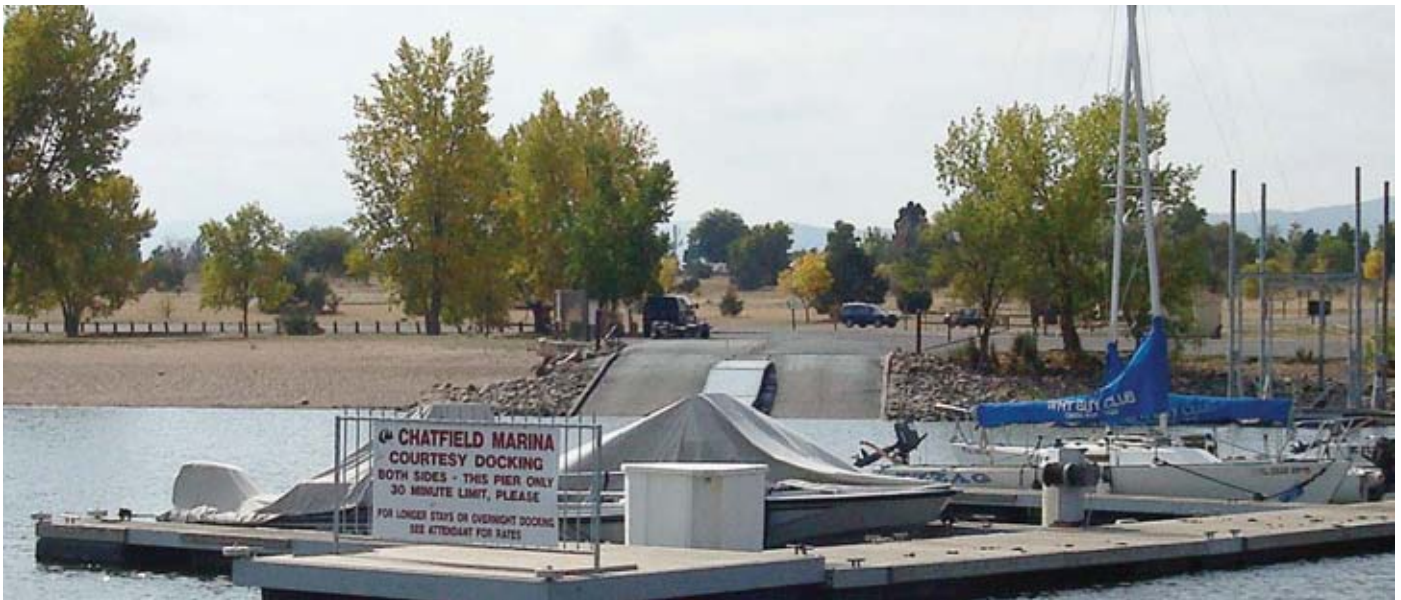
3-23 Launch Ramp

The South Launch ramp provides an alternative launch point to the larger North Ramp and is used for service and storage access at the marina. The parking lot adjacent to the ramp is separated from the marina users parking area.
